**Maine Department  
Of  
Environmental Protection**

**DISPENSER  
AND  
SUBMERSIBLE PUMP  
STUDY**

Marcel Moreau Associates

October 2003

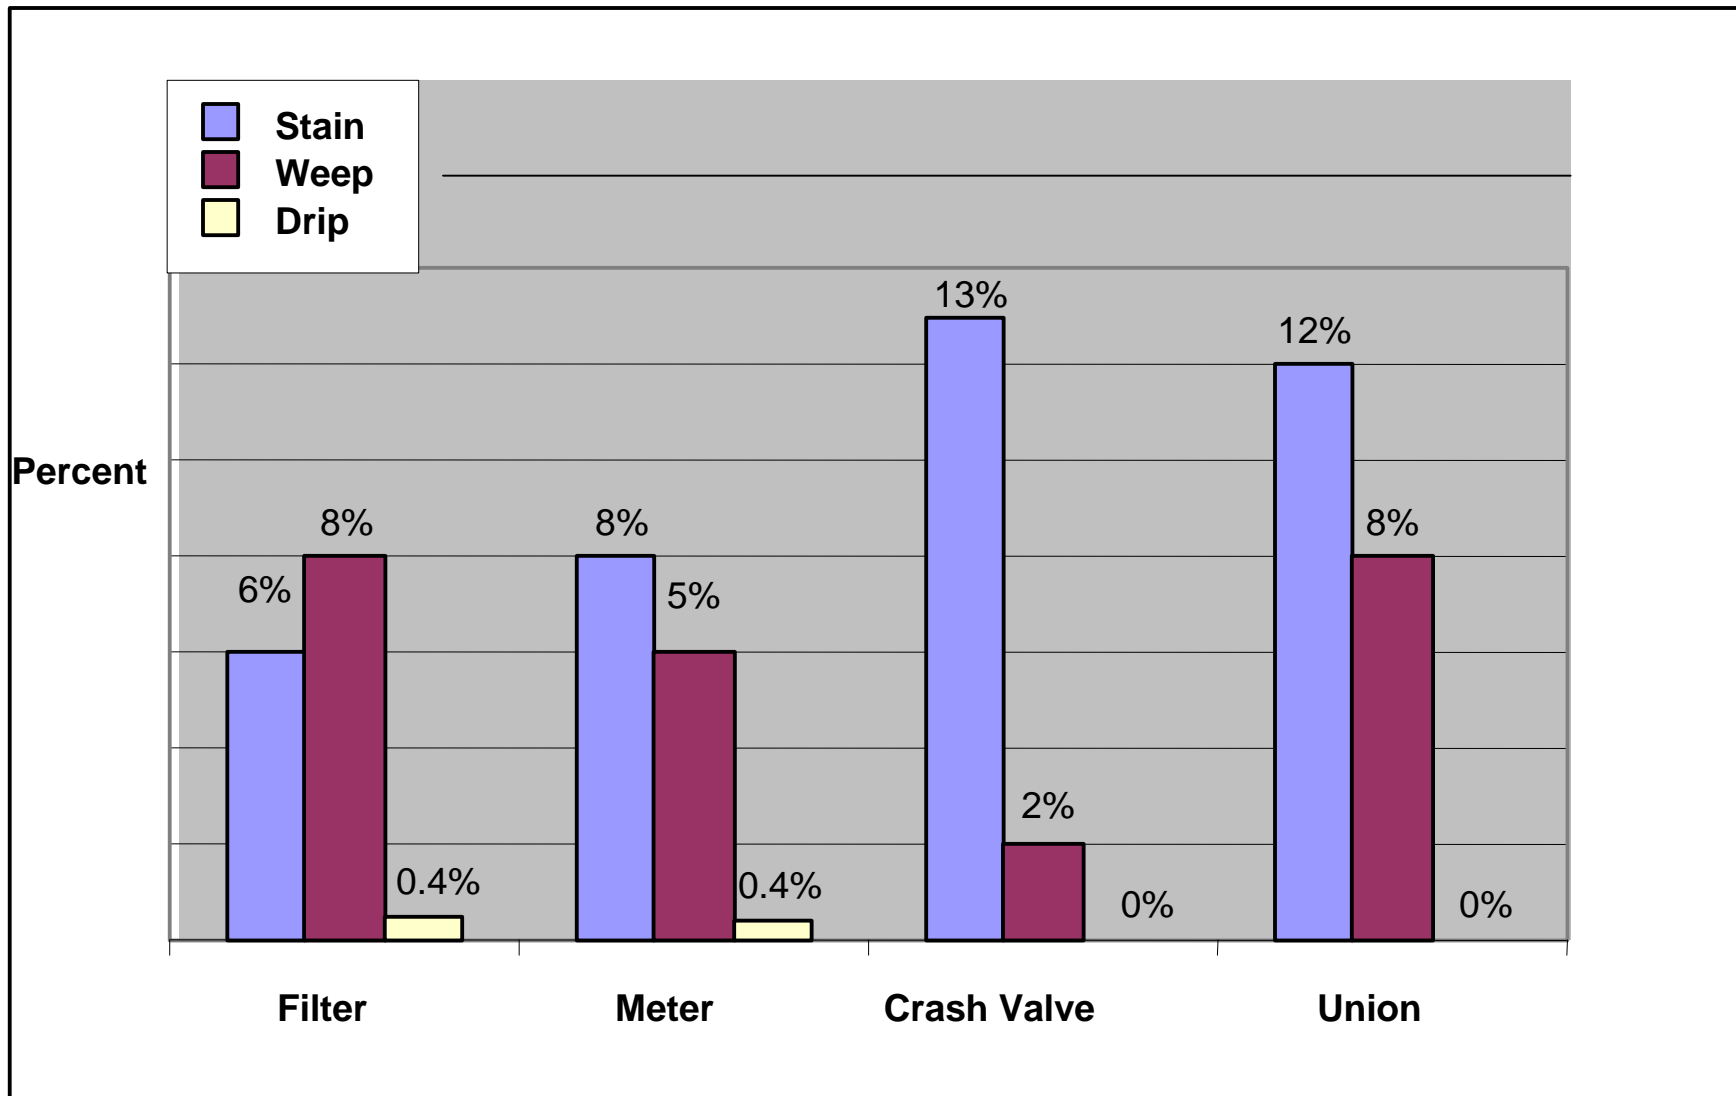
**Figure 5:** What Was the Frequency and Severity of Leaks Observed in Dispenser Components?

Filter		Meter		Crash Valve		Union	
	Number	Percent	Number	Percent	Number	Percent	Number	Percent
Clean	383	85.5	703	86.4	280	85.4	354	79.6
Stained	26	5.8	64	7.9	42	12.8	55	12.4
Weeping	37	8.3	44	5.4	6	1.8	36	8.1
Dripping	2	0.4	3	0.4	0	0	0	0
Total Inspected	448	100.0	814	100.1	328	100.0	445	100.1

Filters and meters were the only actively dripping dispenser components observed during the study. Because crash valves are typically installed immediately below unions, it was sometimes difficult to distinguish stains and weeps originating from unions from those originating from the crash valve. In most cases, if the union above a crash valve showed significant staining or weeping that extended down to the crash valve, the stain or weep was attributed to the union and NOT the crash valve.

The dispenser component most frequently exhibiting some sign of a leak (stain, weep, or drip) was the union, while the more severe leaks (drips) were most frequently observed in filters and meters. Some 20.4 percent of the unions inspected showed some evidence of a leak. Crash valves, filters and meters shared approximately the same overall frequency of leakage at 14.6, 14.5 and 13.6 percent respectively. In terms of the most severe leaks (drips), filters and meters were the same at 0.4 percent. Weeping filters and unions were observed 8.3 and 8.1 percent of the time respectively, while 5.4 percent of meters and 1.8 percent of crash valves were found to be weeping.

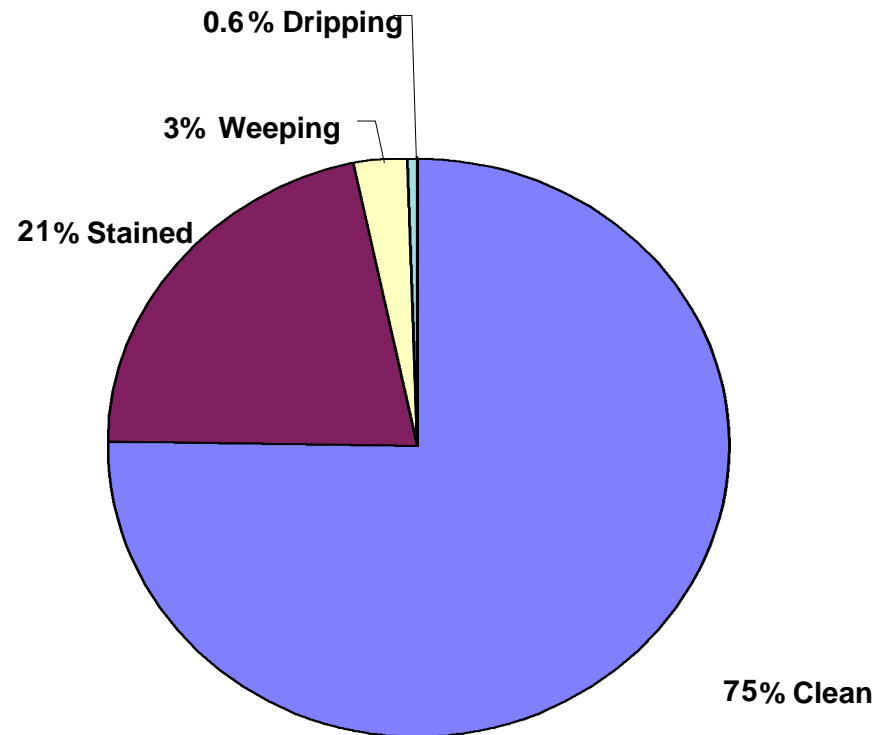
**Figure 6:** What was the Frequency and Severity of Leaks Observed in Suction Pumps?

Suction Pumps	
	Number	Percent
Clean	116	75.3
Stained	32	20.8
Weeping	5	3.2
Dripping	1	0.6
Total Inspected	154	99.9

Of the 154 suction pumps inspected, one had a serious drip from a leak around the drive pulley bearing.

Staining was observed on suction pumping units 20.8 percent of the time, 3.2 percent of suction pumps were weeping and 0.6 percent were dripping.

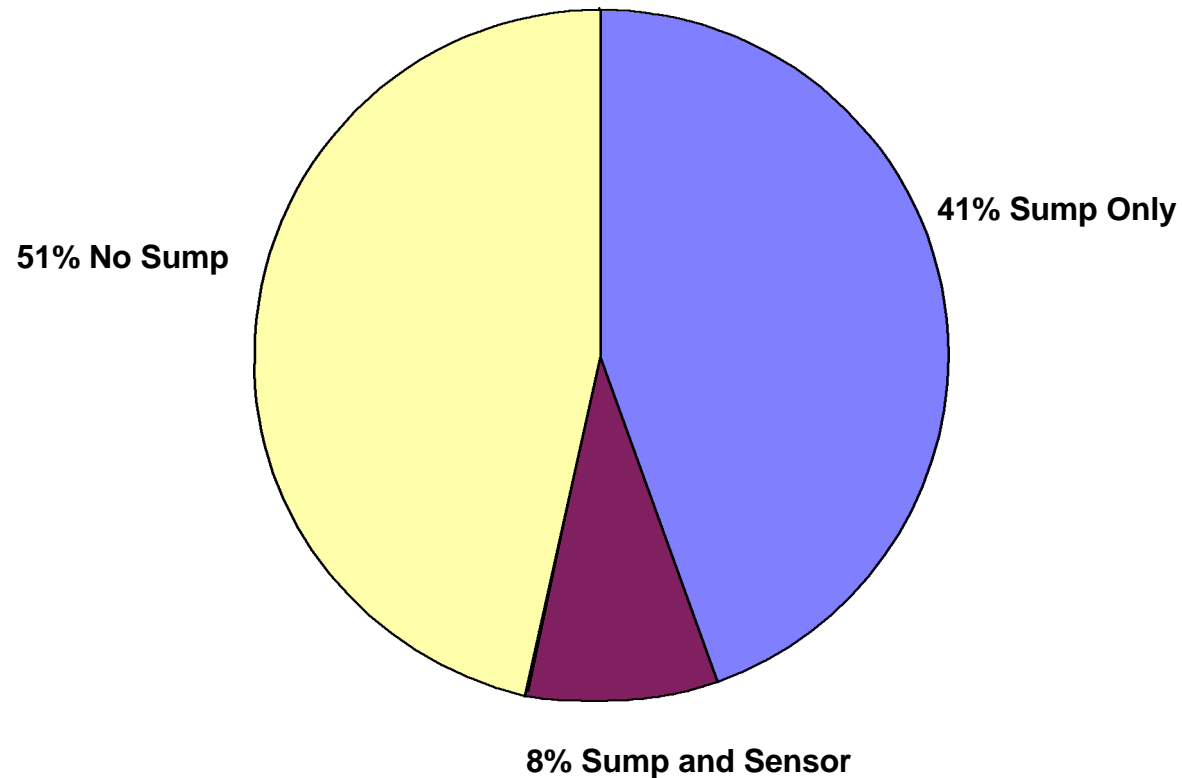
**Figure 7: What Percentage of Dispensers Were Equipped with Containment Sumps and Sensors?**

Dispenser Containment Sumps	
	Number	Percent
<b>No Sump</b>	<b>128</b>	<b>50.6</b>
<b>Sump Only</b>	<b>104</b>	<b>41.1</b>
<b>Sump and Sensor</b>	<b>21</b>	<b>8.3</b>
<b>Total Dispensers Inspected</b>	<b>253</b>	<b>100.0</b>

Some 125 (49 percent) of the dispensers that were inspected were equipped with containment sumps. Of these 125, only 21 (17 percent) were equipped with sensors. Dispenser sumps without sensors rely completely on the integrity of the dispenser sump and the secondary containment piping to channel a release back to the containment sump at the top of the tank. At facilities with multiple dispensers, successful detection of a leak in the furthest dispenser would depend on the integrity of multiple dispenser sumps and numerous secondary containment piping/sump connections.

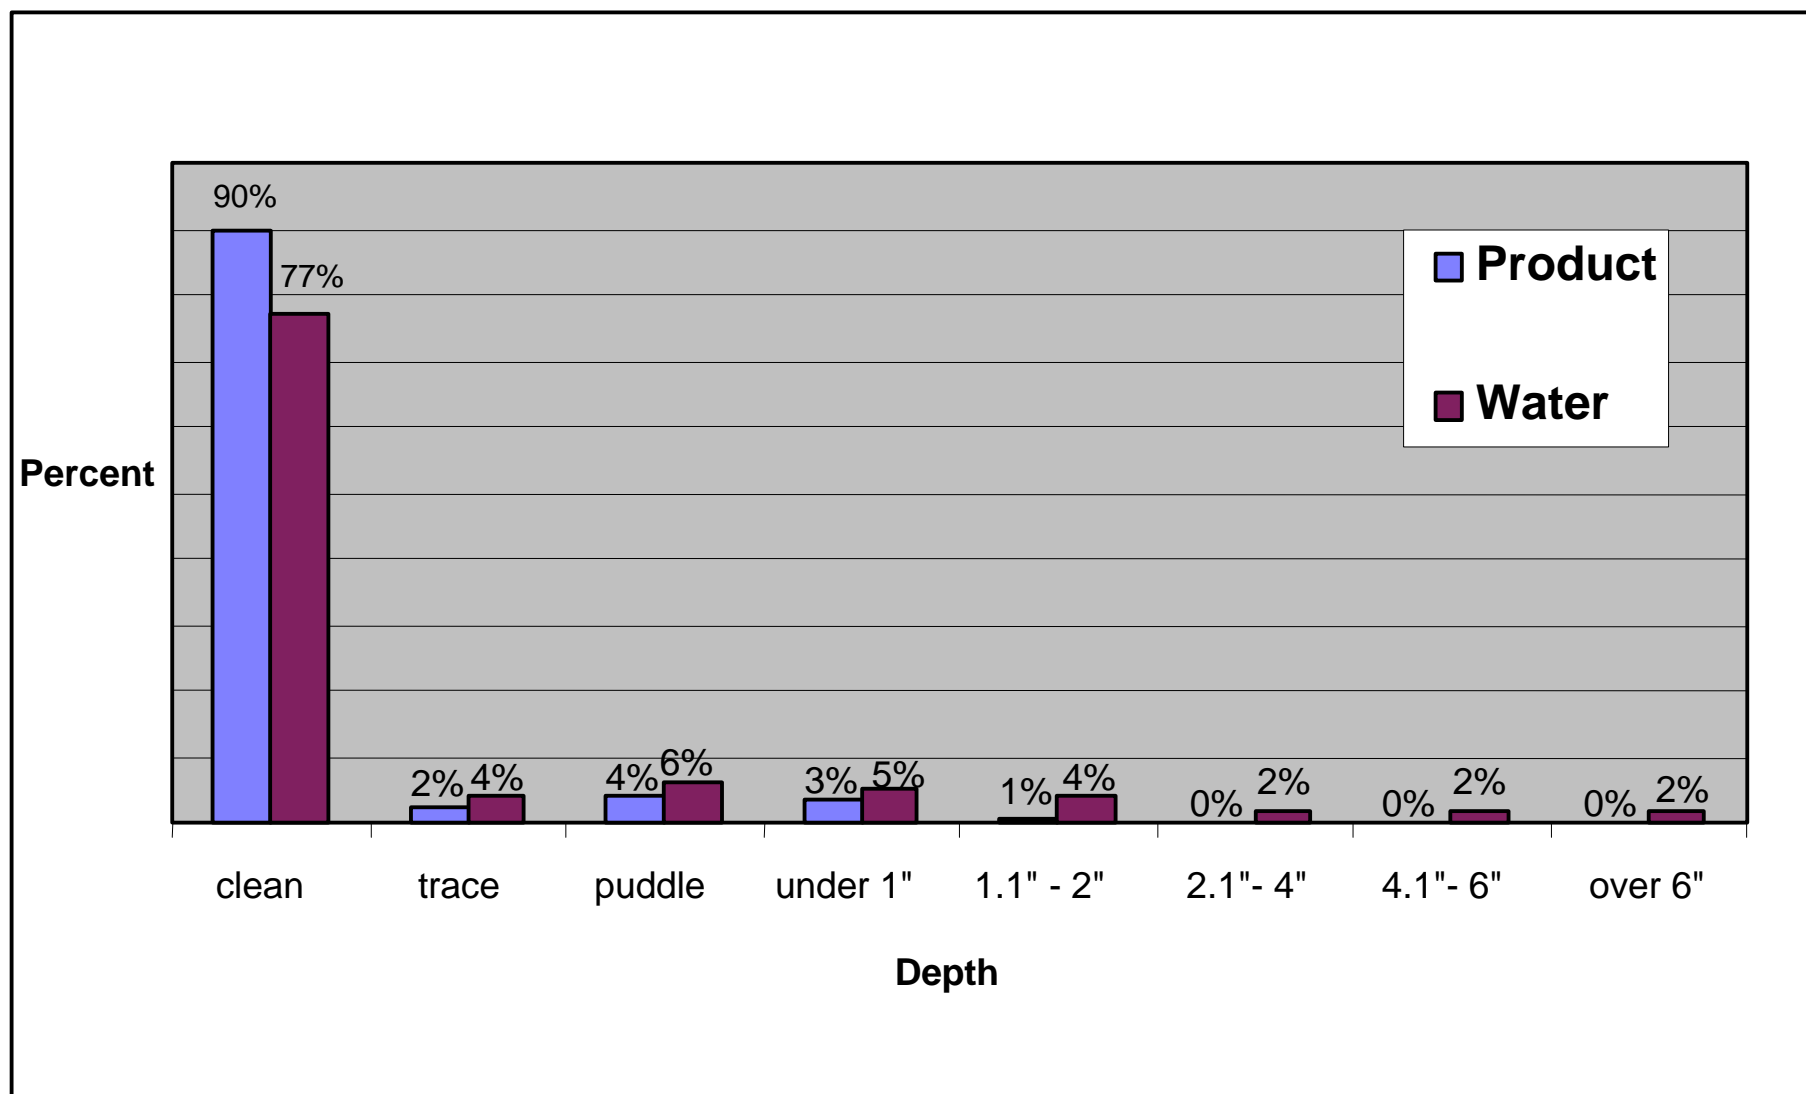
**Figure 8:** What Was the Depth and Frequency of Occurrence of Water and Product in Dispenser Sumps?

Product		Water	
	Number	Percent	Number	Percent
Clean	112	89.6	96	76.8
Trace <sup>1</sup>	3	2.4	5	4.0
Puddle <sup>2</sup>	5	4.0	7	5.6
Under 1” <sup>3</sup>	4	3.2	6	4.8
1.1” – 2”	1	0.8	5	4.0
2.1” – 4”	0	0	2	1.6
4.1” – 6”	0	0	2	1.6
Over 6”	0	0	2	1.6
<b>Total Inspected</b>	<b>125</b>	<b>100.0</b>	<b>125</b>	<b>100.0</b>

A measurable amount of water was found in 19.2 percent of dispenser sumps, though only 8.8 percent had more than an inch of water.

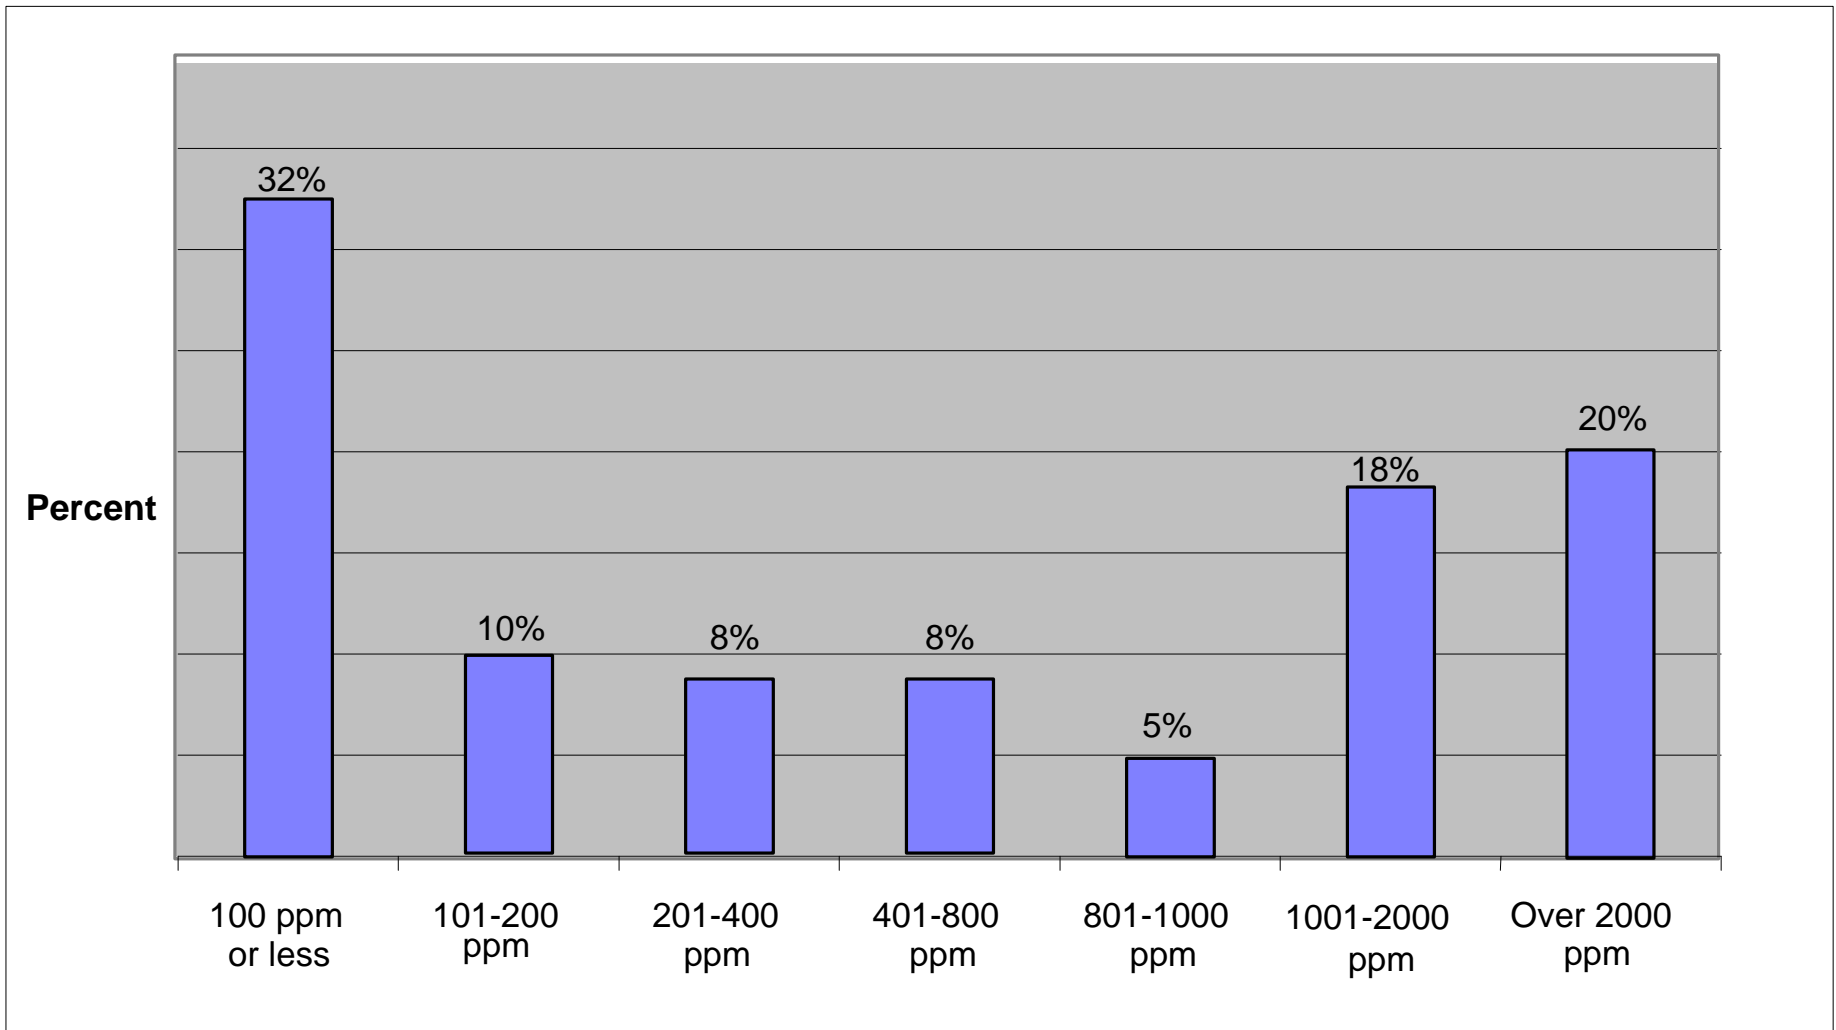
**Figure 9:** What Was the Level of Soil Contamination Beneath Pressure Dispensers without Sumps?

Pressure Dispenser Soil Samples	
	Number	Percent
100 ppm or less	13	32.5
101-200 ppm	4	10.0
201-400 ppm	3	7.5
401-800 ppm	3	7.5
801-1000 ppm	2	5.0
1001-2000 ppm	7	17.5
Over 2000 ppm	8	20.0
<b>Total Inspected</b>	<b>40</b>	<b>100.0</b>

At pressure dispensers without sumps, soil samples were screened for contamination using a PID meter following DEP protocol (refer to the description of the study protocol in Appendix A of this report for further details). Contamination levels less than 100 parts per million (ppm) are considered clean by Maine DEP. Thirty-two percent of pressure dispensers had PID readings below 100 ppm, while 68 percent had contamination levels greater than 100 ppm. Soil samples were taken only a few inches beneath the surface of the soil where volatilization and biodegradation of hydrocarbons would be expected to be fairly rapid. It is unlikely that residual contamination from leaks that occurred years ago would produce the elevated PID readings measured during the study.

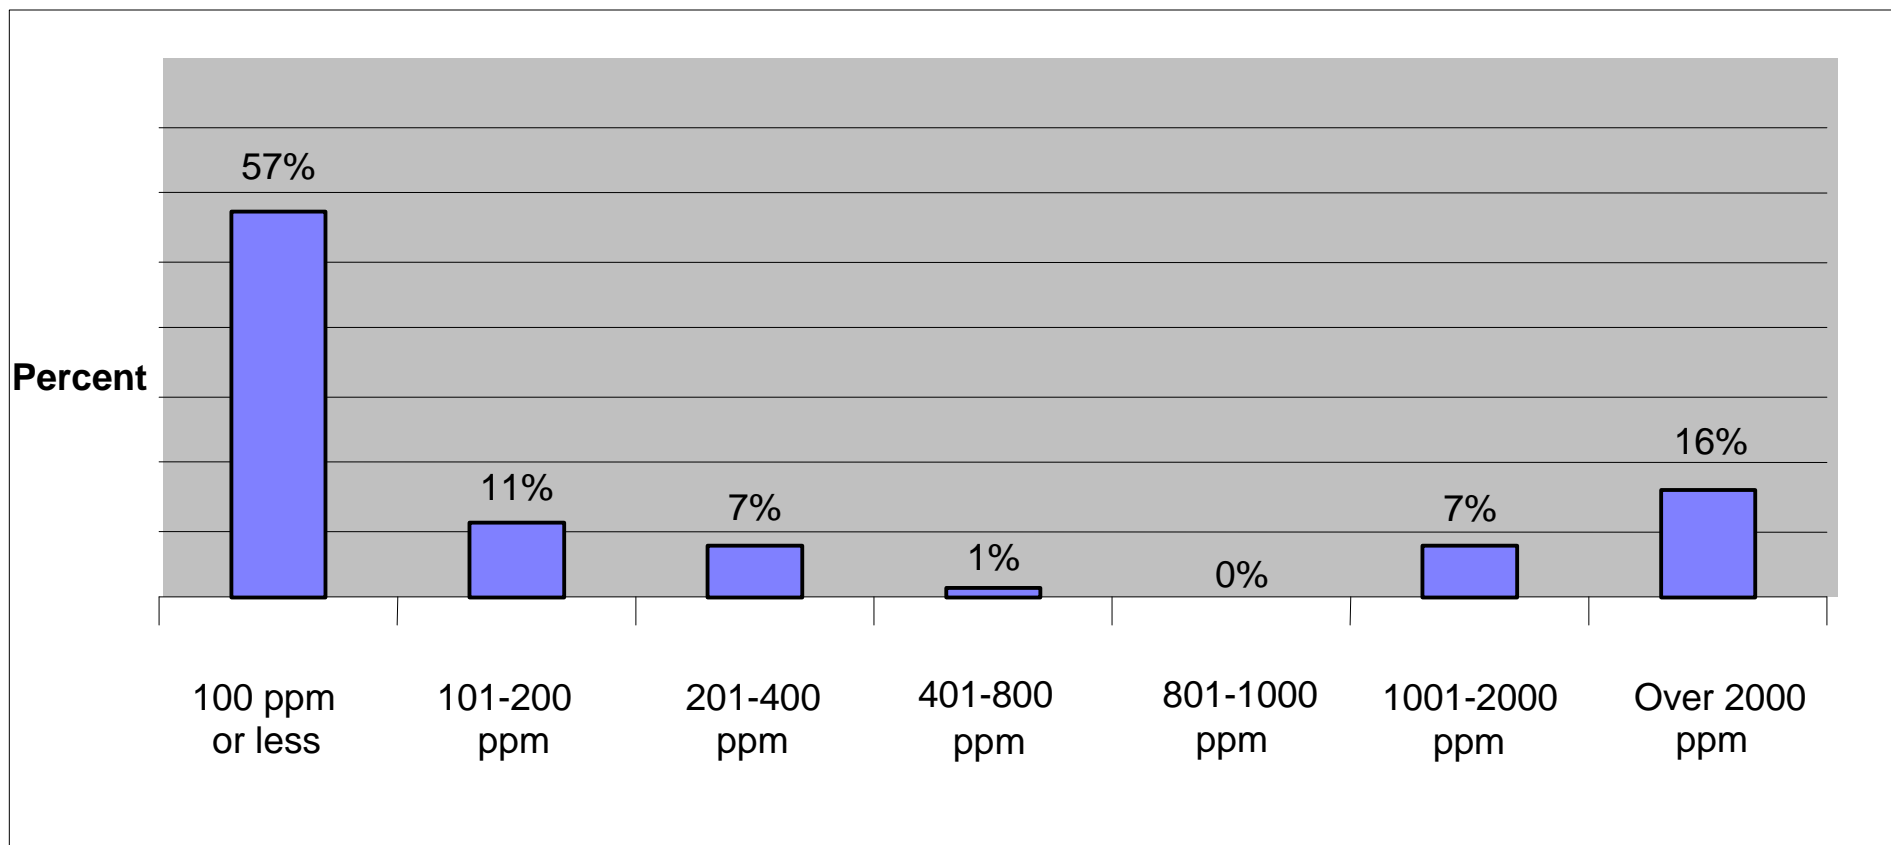
**Figure 10:** What Was the Level of Soil Contamination Beneath Suction Dispensers without Sumps?

Suction Dispenser Soil Samples	
	Number	Percent
100 ppm or less	47	57.3
101-200 ppm	9	11.0
201-400 ppm	6	7.3
401-800 ppm	1	1.2
801-1000 ppm	0	0.0
1001-2000 ppm	6	7.3
Over 2000 ppm	13	15.9
Total Inspected	82	100.0

At suction dispensers without sumps, soil samples were screened for contamination using a PID meter following DEP protocol (refer to Appendix A of this report for further details). Contamination levels less than 100 parts per million (ppm) are considered clean by Maine DEP. Fifty-seven percent of the suction dispensers had PID readings of less than 100 ppm in the soil beneath the dispenser, while 43 percent had levels greater than 100 ppm. Soil samples were taken only a few inches beneath the surface of the soil where volatilization and biodegradation of hydrocarbons would be expected to be fairly rapid. It is unlikely that residual contamination from leaks that occurred years ago would produce the elevated PID readings measured during the study.

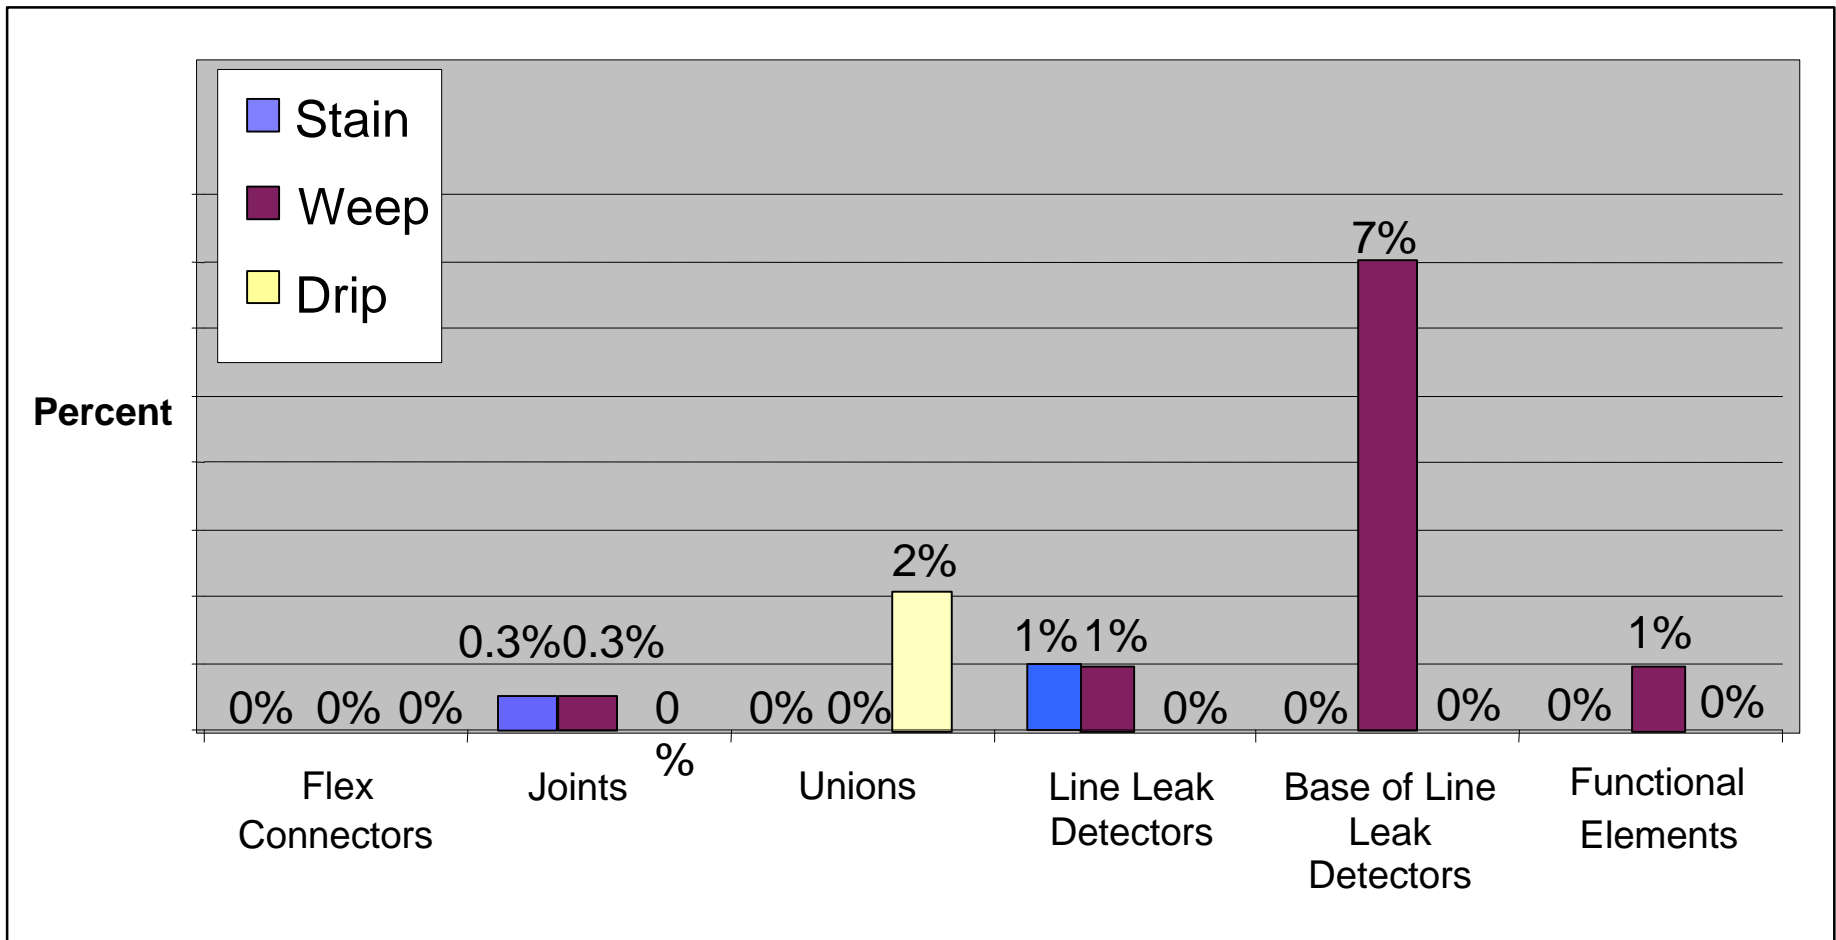
**Figure 11:** What Was the Frequency and Severity of Leaks Observed from Submersible Pumps?

Flex Connectors	
	Number	Percent
Clean	22	100.0
Stained	0	0.0
Weeping	0	0.0
Dripping	0	0.0
Total Inspected	22	100.0

Line Leak Detectors	
	Number	Percent
Clean	105	98.1
Stained	1	0.9
Weeping	1	0.9
Dripping	0	0.0
Total Inspected	107	99.9

Base of Line Leak Detectors	
	Number	Percent
	100	93.5
	0	0.0
	7	6.5
	0	0.0
	107	100.0

Although stains were the most commonly observed evidence of leakage in dispensers, they were virtually absent from submersible pumps. The threaded joint between the base of line leak detectors and submersible pump manifolds was the location where weeping product was most frequently observed. In a number of cases, submersible pump containment sumps had very strong gasoline odors when they were initially opened, but no evidence of leakage could be located.

The submersible pump component most frequently exhibiting some sign of a leak (stain, weep or drip) was the base of line leak detectors at 6.5 percent. Next in order of frequency were unions at 2.0 percent, line leak detectors at 1.9 percent, functional elements at 0.9 percent and threaded joints at 0.7 percent. In terms of the most severe leaks observed, 2.0 percent of unions were found to be dripping. Weeps were observed at 6.5 percent of line leak detector bases, while 0.9 percent of functional elements and line leak detectors, and 0.3 percent of threaded joints exhibited weeps. Staining was rarely observed in submersible pump sumps. Only 0.9 percent of line leak detectors and 0.3 percent of threaded joints showed stains.

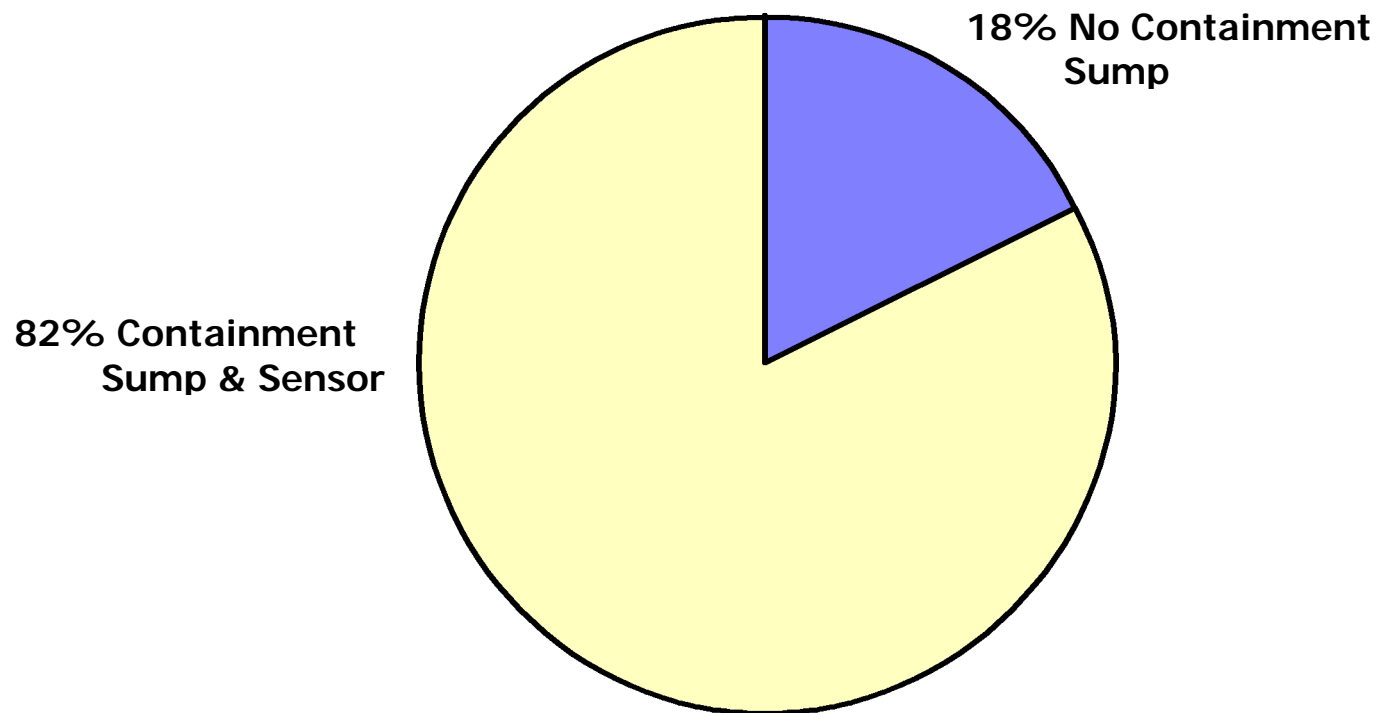
**Figure 12:** What Percentage of Submersible Pumps Were Installed in Containment Sumps with Sensors?

Submersible Pumps	
	Number	Percent
No Containment Sump	19	17.9
Containment Sump and Sensor	87	82.1
Total Submersible Pumps Inspected	106	100.0

There was one facility where two submersible pumps were installed in one containment sump. As a result, the total number of submersible pump sumps inspected was 106, while the number of submersible pumps inspected was 107. Nine tank top containment sumps that contained various fittings, but did NOT contain submersible pumps, were also encountered in the course of the study. These containment sumps without pumps are not included in the study statistics. All of the submersible pump containment sumps inspected during this study were equipped with sensors.

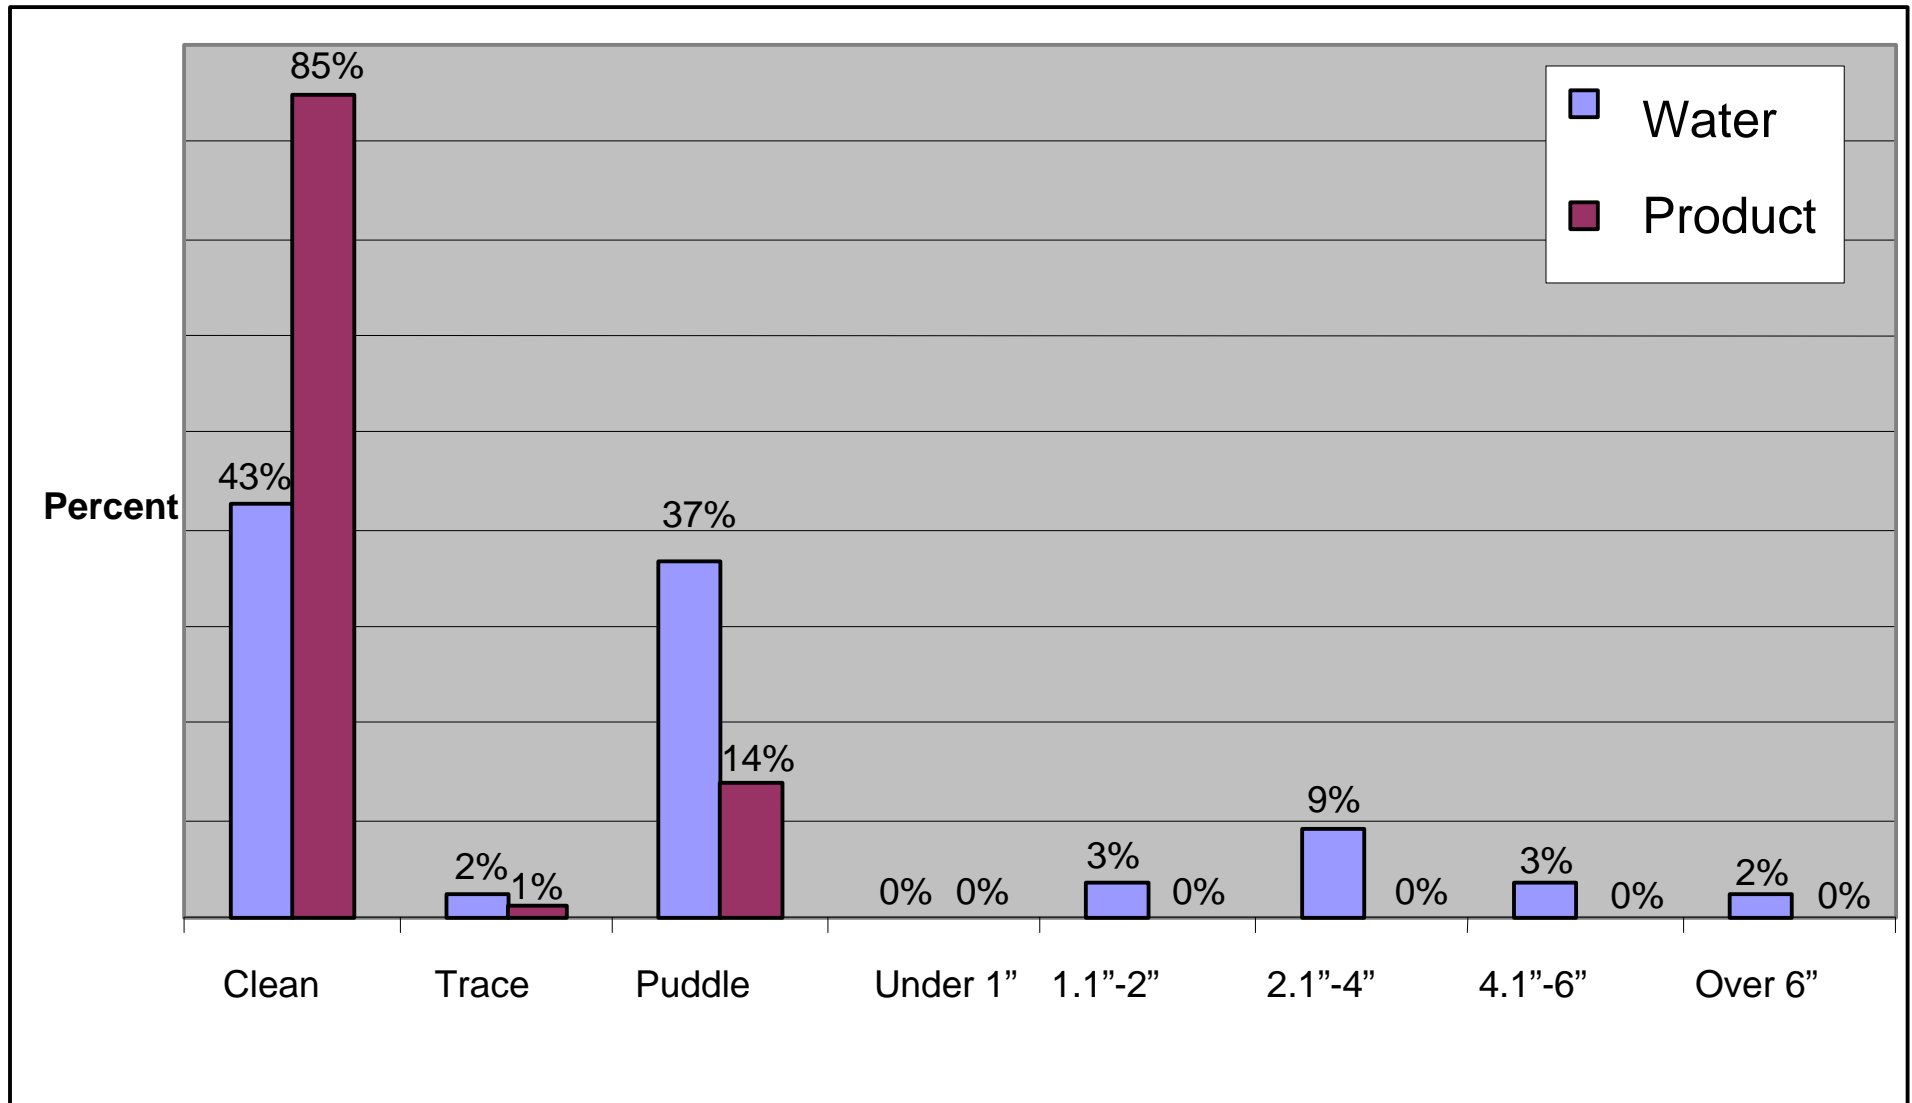
**Figure 13:** What Was the Depth and Frequency of Occurrence of Water and Product in Submersible Pump Sumps?

Water			Product	
	Number	Percent		Number	Percent
Clean	37	42.5		74	85.1
Trace	2	2.3		1	1.1
Puddle	32	36.8		12	13.8
Under 1"	0	0.0		0	0
1.1"-2"	3	3.4		0	0
2.1"-4"	8	9.2		0	0
4.1"-6"	3	3.4		0	0
Over 6"	2	2.3		0	0
Total Inspected	87	99.9		87	100.0

A trace was defined as a depth of liquid too shallow to measure accurately. A puddle was defined as a small amount of liquid that had measurable depth but did not cover the entire bottom of the sump. Where inch measurements are indicated, the entire bottom of the sump was covered with liquid and the measurement reflects the greatest measured depth. Some 18 percent of submersible pump sumps contained more than an inch of water, but none contained more than a puddle of product.

Water was found in 55.2 percent of submersible pump sumps, and 18.4 percent had more than 1 inch of water.

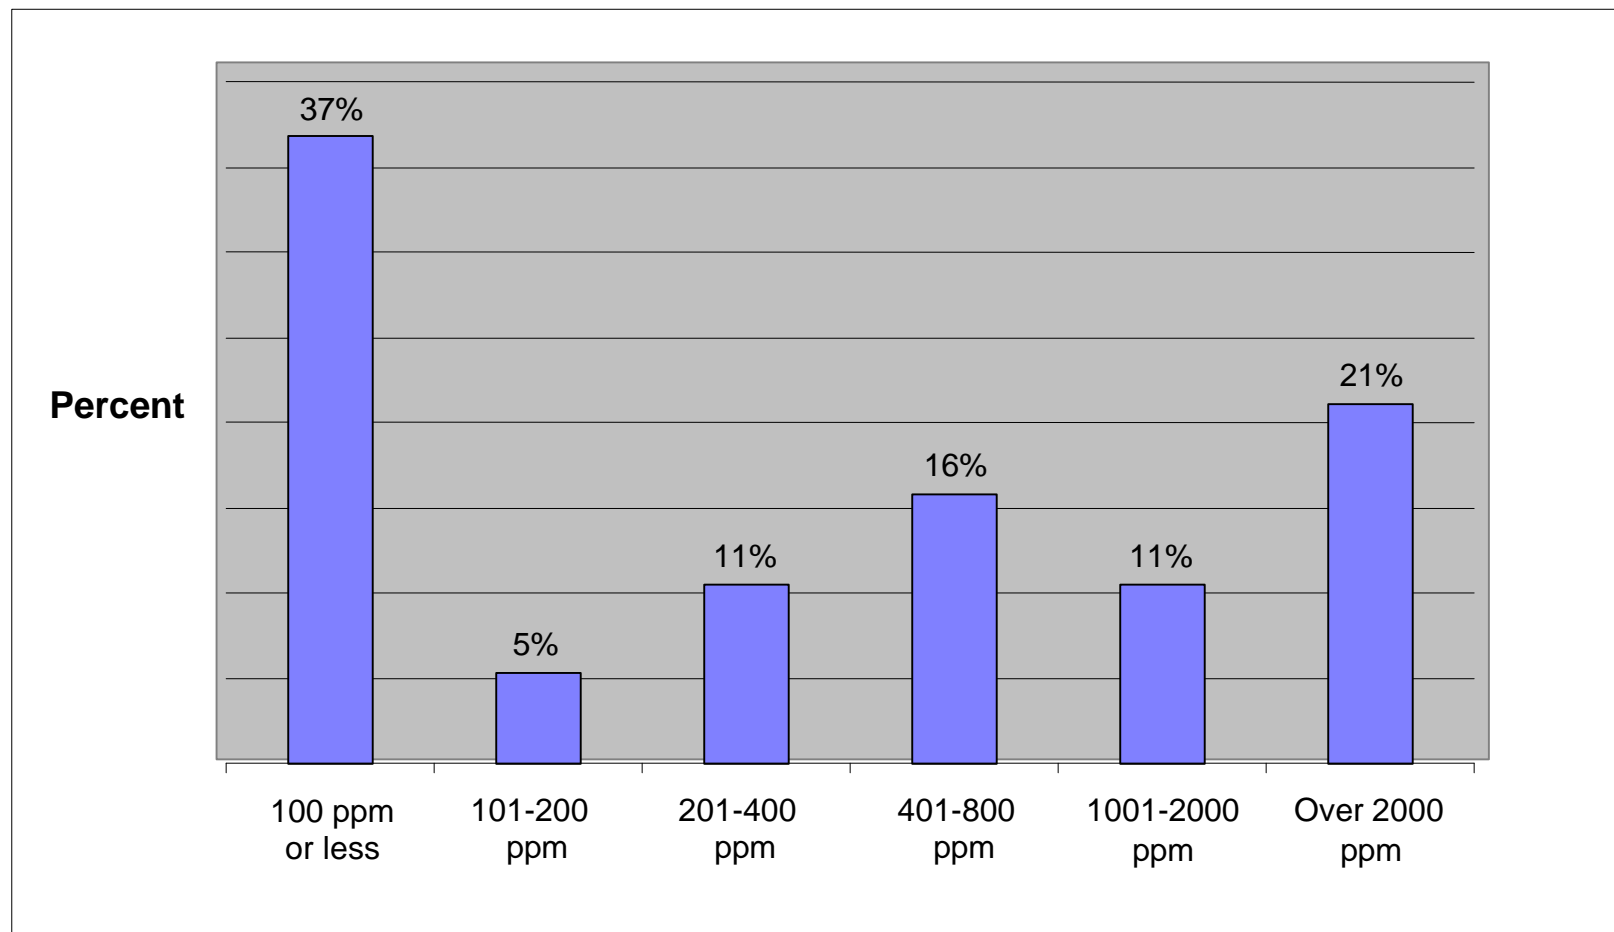
**Figure 14:** What Was the Level of Contamination Beneath Submersible Pumps without Containment?

Soil Beneath Submersible Pumps	
	Number	Percent
100 ppm or less	7	36.8
101-200 ppm	1	5.3
201-400 ppm	2	10.5
401-800 ppm	3	15.8
1001-2000 ppm	2	10.5
Over 2000 ppm	4	21.1
<b>Total Inspected</b>	<b>19</b>	<b>100.0</b>
